Case Study

Special surgery to treat 35 year-old woman with **unusual neck fracture**.

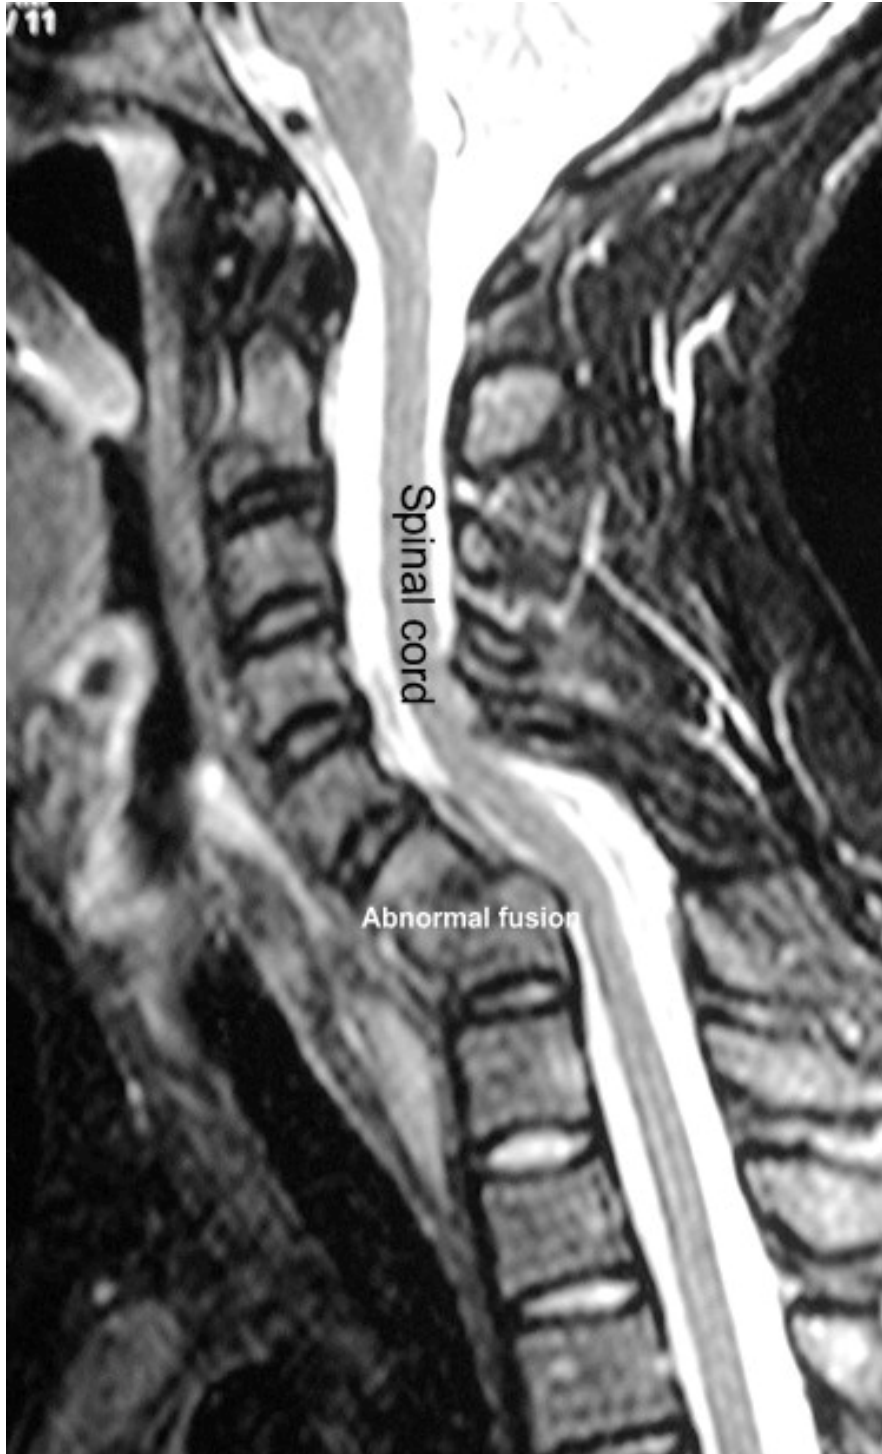
MRI image of patient's cervical spine prior to surgery showing severe deformity secondary to misaligned fusion of her vertebrae:

The x-rays and scans were indeed dramatic. Her neck had broken in the front and back. Likely, the slip had developed over time, one cervical vertebrae sagging on the vertebrae below, until it could slide no further, and then healed. The roof of the spinal canal had broken off during the accident and had spared her from injuring her spinal cord. Over time, the fractures had fused solidly. The choices were limited: continue pain medications and pain therapies, which were not helping, or “re-break” the neck in a controlled fashion, correct the misalignment, stabilize the spine, and allow time for bone fusion to occur again. In view of the worsening pain, her problems with numbness and walking, and her young age, there was really only one good option.

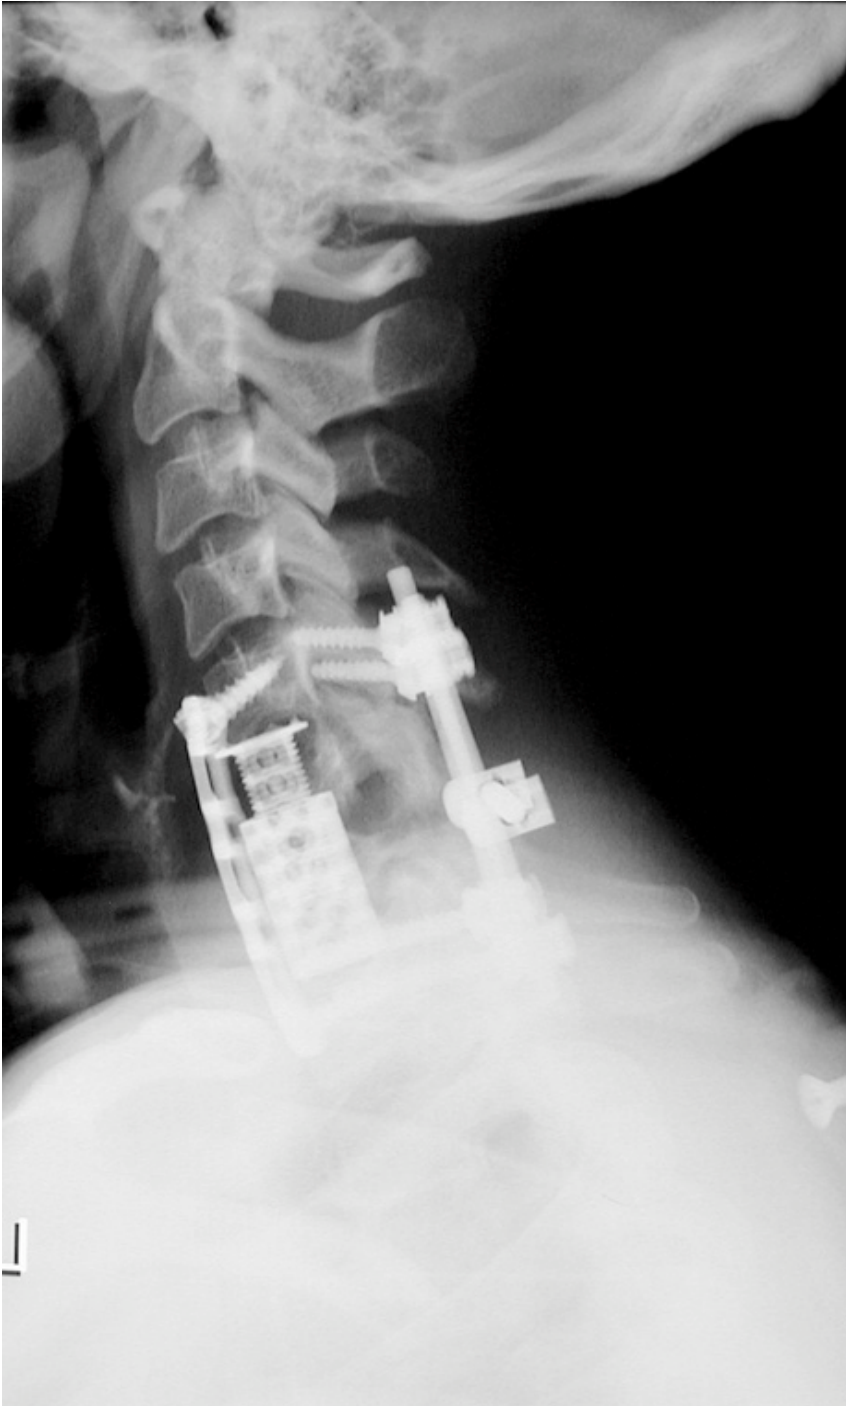
Postoperative XR of the cervical spine after anterior and posterior fusion with a complete correction of the deformity:

The surgical procedure consisted of three surgeries in one, all performed on the same day. During the first procedure, through an incision in the back of the neck, the fusion of the back part of the spine (the lamina and facets) was surgically released and the wound was closed. Then, through an incision in the front of the neck, the two crushed vertebrae were removed and, carefully using traction under x-ray guidance, the neck was straightened. A special “cage” implant filled with bone chips was implanted to reconstruct the vertebrae and was then secured with a titanium plate attached to the front of the spine. This wound was then closed, she was turned back over on the operating table and the previous neck wound was re-opened. Screws and rods were attached to the back of the spine to further stabilize the spine. An external halo brace was the final security used to ensure her spine would hold together while waiting for bone healing to occur.
